MEMORANDUM

RE: Visually Impaired Access at Proposed Roundabouts for Philo Road/Florida Avenue and Race Street/Windsor Road

**EXHIBITS FOR VISUALLY IMPAIRED
PEDESTRIANS AT ROUNDABOUTS**

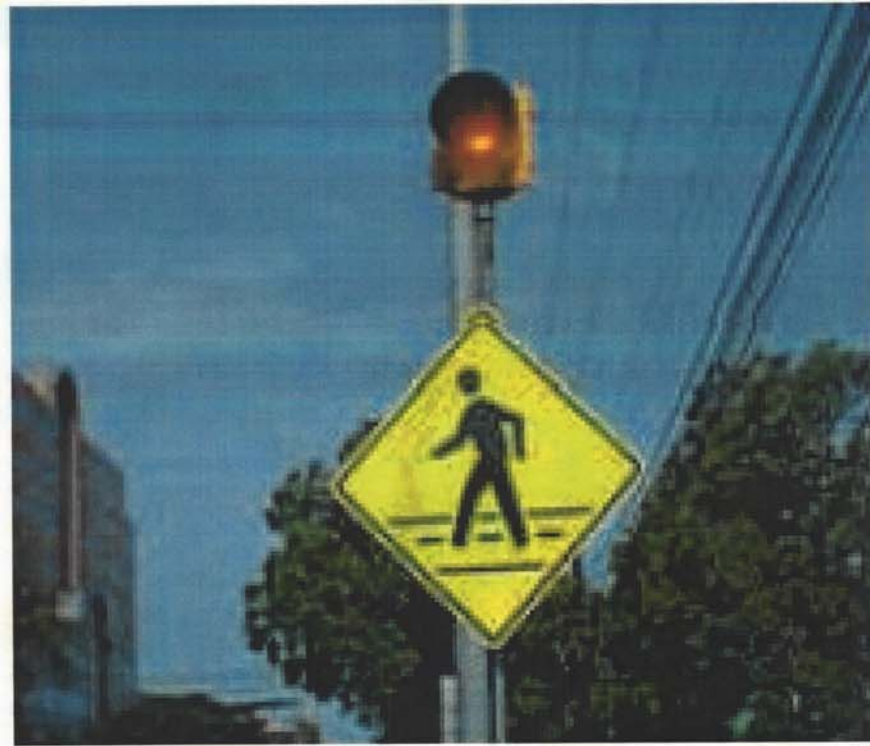
EXHIBIT A
Standard Flashing Beacon

1. Driver information treatments. Examples are a standard continuous flashing beacon (Exhibit A), or an in-roadway warning sign such as “State Law – Stop for Pedestrians”(Exhibit B), or active-when-present flasher beacon which are push button activated and may also have an auditory cue that tells the visually impaired pedestrian the beacon is on. A new technology being used is Rectangular Rapid Flash Beacon (RRFB) (Exhibit C) which uses an irregular flash pattern with high intensity amber LEDs and in studies has shown an increased driver yielding rate to pedestrians over traditional flashing overhead or side of the road beacons.

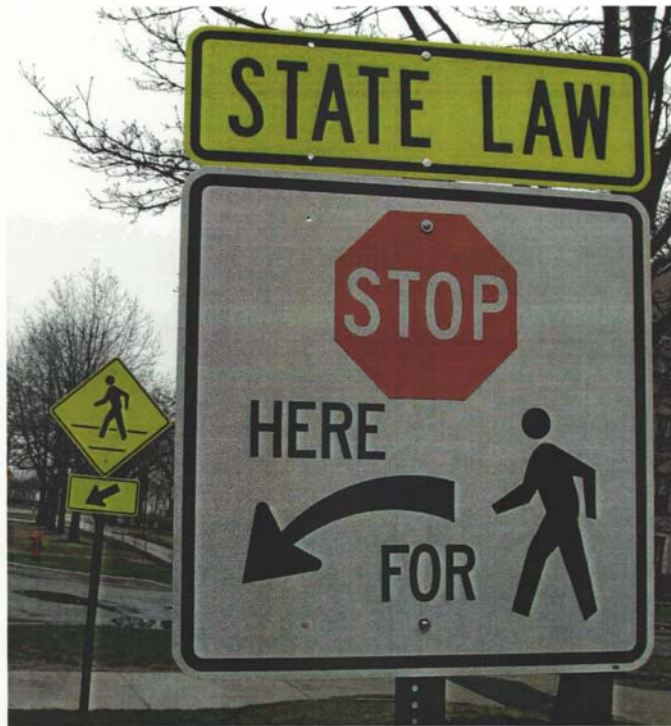
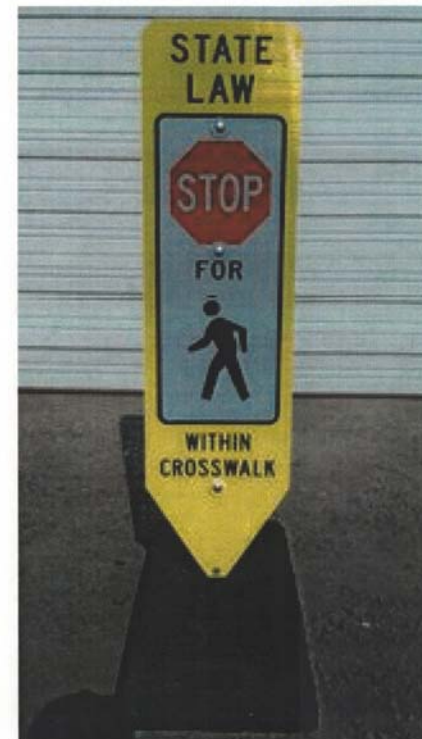
EXHIBIT B

State Law-Stop for Peds Sign

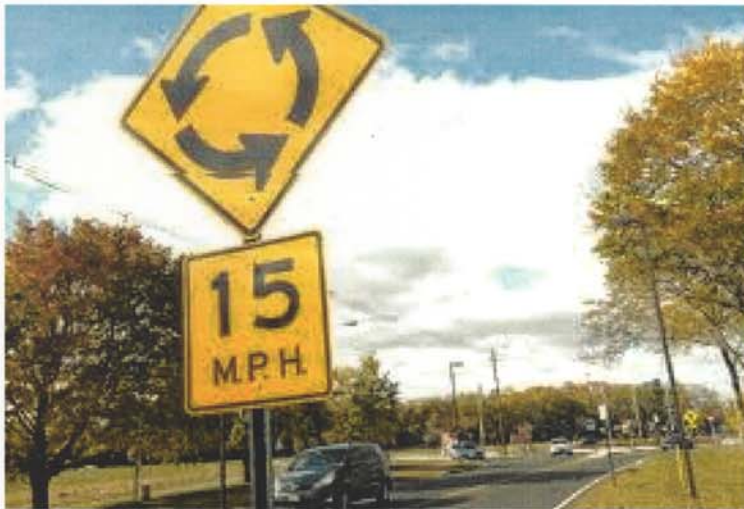
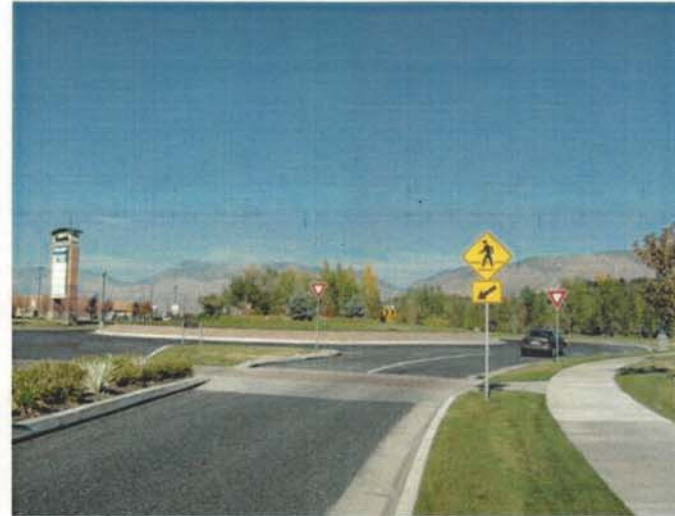
EXHIBIT D
Posting Lower Speed Limits and
Installing Raised Crosswalk

2. Traffic calming treatments. Examples of traffic calming treatments include posting lower speed limits or installing a raised crosswalk (Exhibit D).
3. Pedestrian information treatments. Examples of pedestrian information treatments include pavement surface alterations/rumble strips (Exhibit E) which generate auditory cues of approaching or yielding traffic. Other more complex and costly methods are yield detection systems, gap-detection systems and combination yield and gap detection systems.

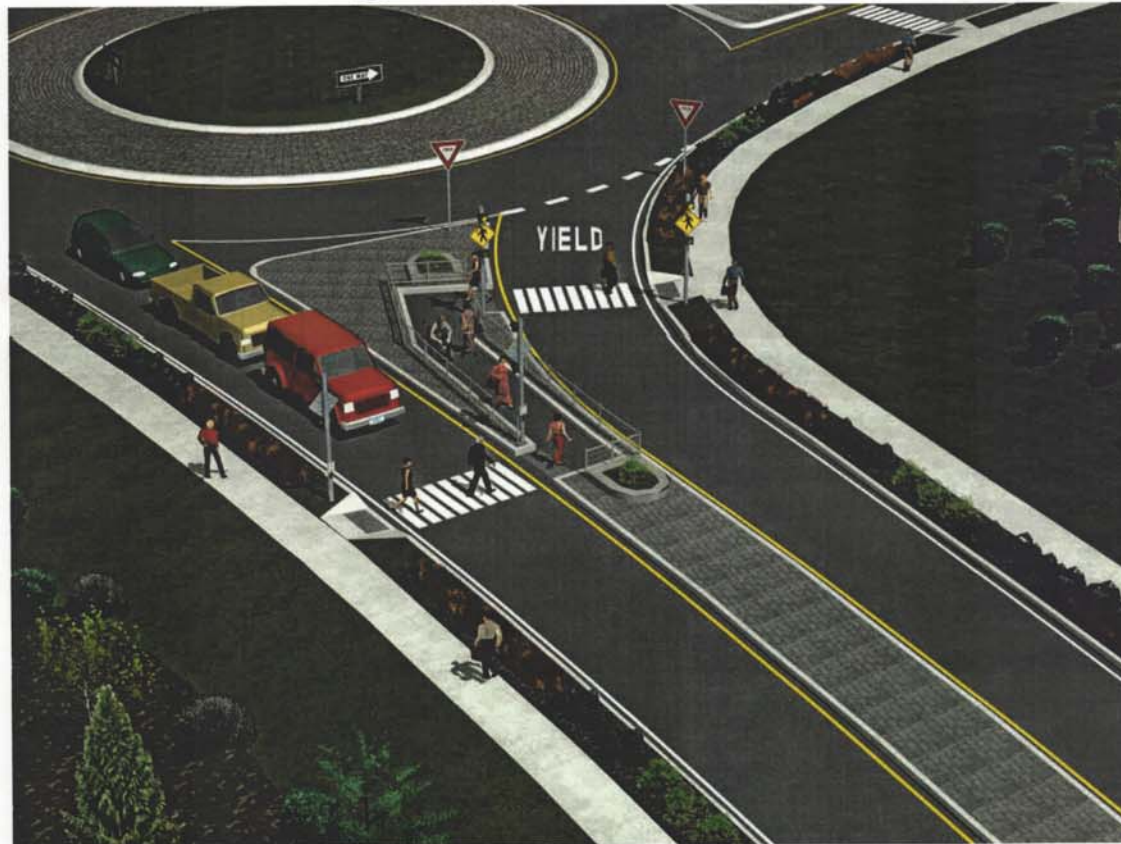
EXHIBIT F Zigzag Crosswalk

4. Crosswalk geometry modifications. This approach would place all or parts of the crosswalk further away from the circulating lane to separate pedestrian-vehicle interaction. The most promising is the offset or zigzag crosswalk (Exhibit F) which moves one leg of the crosswalk on the roundabout exit lane farther away from the circulating traffic in the roundabout. Another idea is to move all the crosswalks away from the roundabout and manage the pedestrian crossings mid-block (Exhibit G).

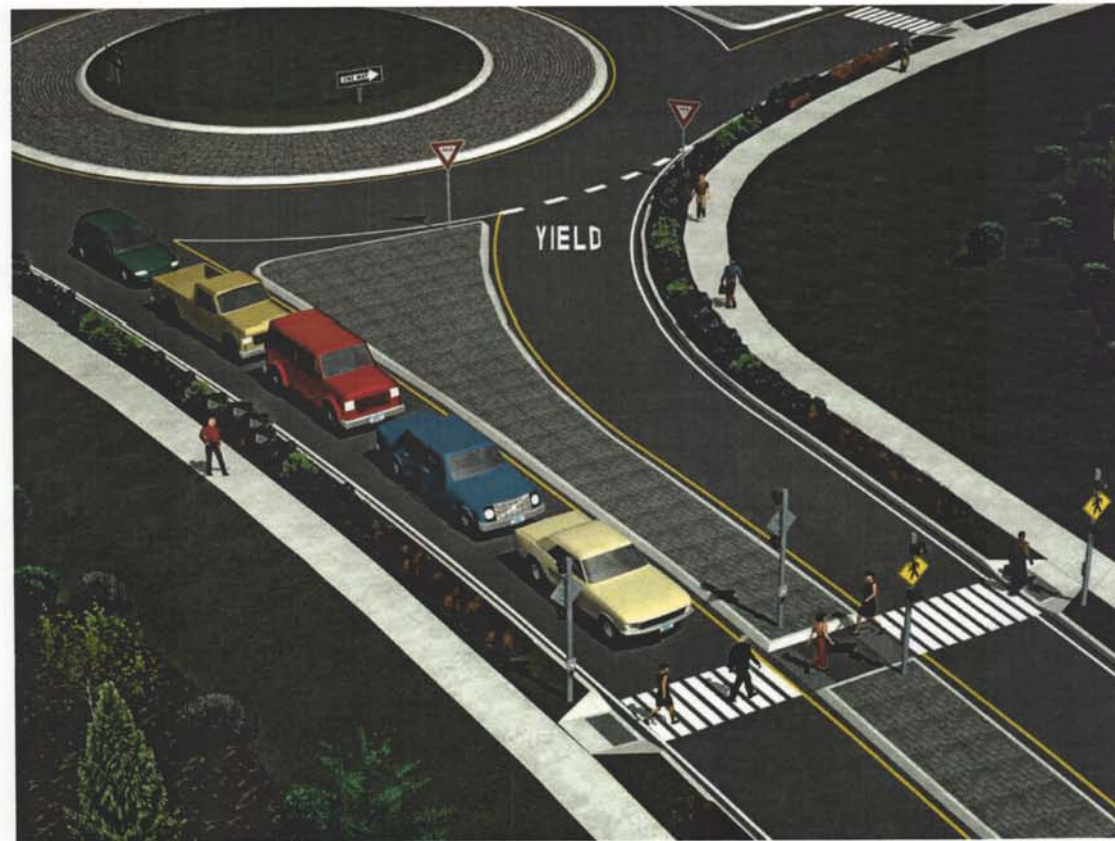
EXHIBIT G

Crosswalk located farther away

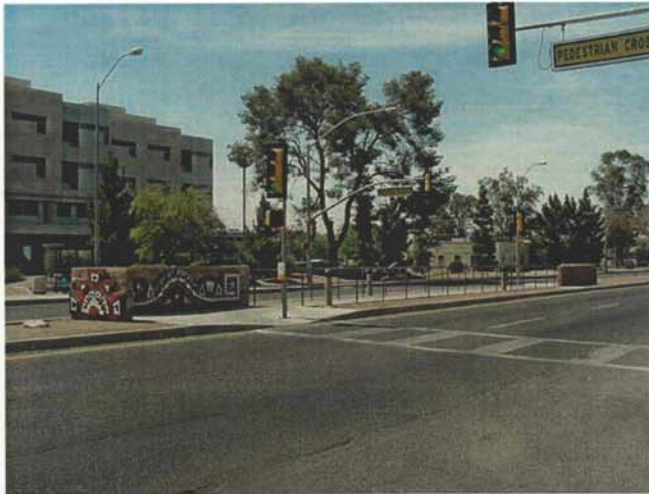
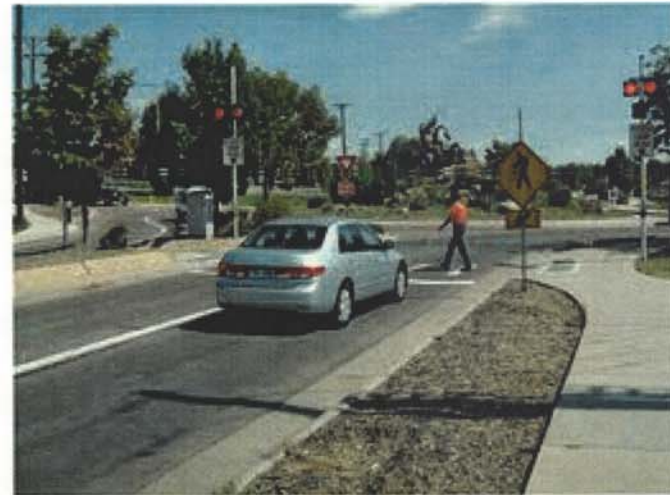
EXHIBIT H PELICAN and HAWK Signals

5. Signalization treatments with APS. Examples include a pedestrian scramble phase, or pedestrian-actuated signals with traditional 3 color signals or PELICAN abbreviated from PEdestrian Light Control Activation, or using a pedestrian hybrid beacon also know as HAWK abbreviated from High intensity Activated CrossWalk (Exhibit H), or pedestrian-actuated signals either at locations upstream or downstream from the roundabout in a mid-block setting using either the HAWK or PELICAN signal. Signals at roundabouts represent a more costly and intrusive treatment for providing a safe crossing environments for pedestrians. They may also introduce delays to both pedestrians and vehicles. Additionally, vehicle queues can spill back on the roundabout exit from the signal to affect roundabout circulating flow. In regards to multi-lane roundabouts, the current 2011 draft of PROWAG (Public Rights-of-Way Access Guidelines) endorsed by the FHWA, includes a requirement to install accessible pedestrian signals at all crosswalks across any roundabout approach with two or more lanes in one direction. This requirement for multi-lane roundabouts can typically add \$160,000 to \$200,000 to the project.

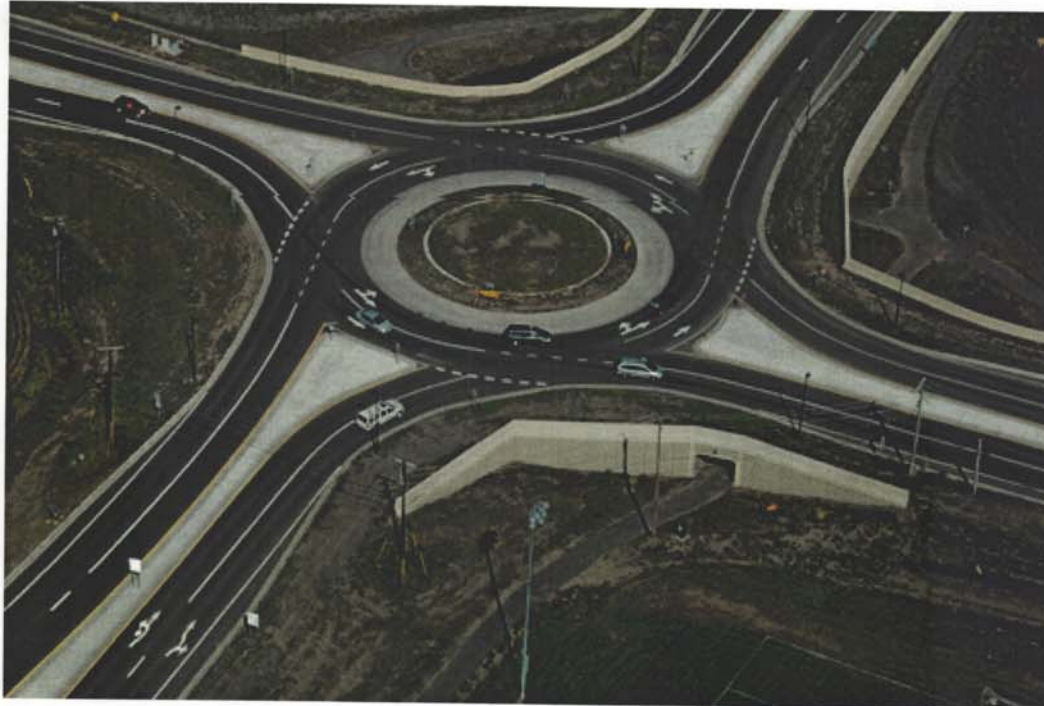
EXHIBIT I
Example of Underpass
Pedestrian Crossing

6. Grade-separated crossings. Examples are overpasses or underpasses (Exhibit I). While a preferred solution they are not an option in this circumstance due to very large capital expense, purchase of additional right-of-way and visually impaired users may not actually use them.
