## DEPARTMENT OF COMMUNITY DEVELOPMENT SERVICES

**SUBJECT:** evaluation of conditions, 104 N. Central Ave. (Halberstadt House) (Plan Case 2010-L-02)

### **Conditions Report**

SUBJECT: 104 N. Central, Halberstadt House  
Building Safety Division Inspection

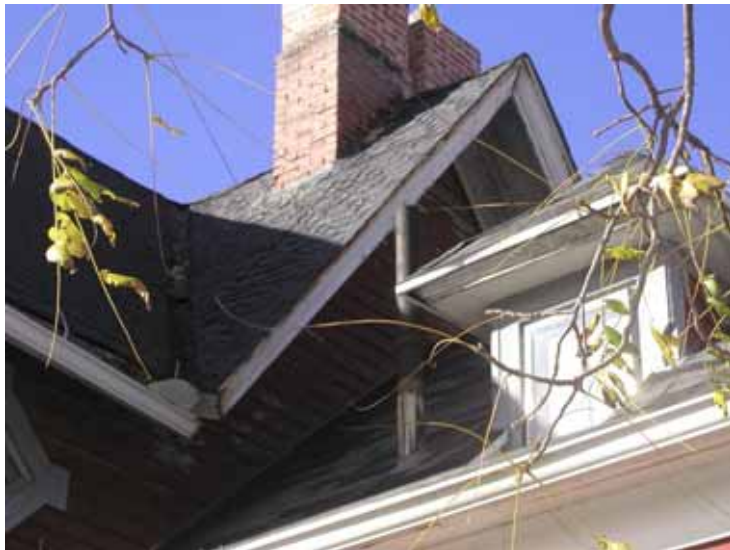
Roof. The building has a traditional pitched roof now clad with multiple layers of asphalt roofing material. The front half of the roof is now covered with roll roofing which has been incorrectly installed vertically rather than horizontally. The rear half of the roof has traditional three-tab asphalt shingles. These are extremely deteriorated and obviously need to be replaced soon. All layers of shingles must be removed down to decking, and new flashing and shingles installed. Most likely some or all of the roof decking would need to be replaced, depending on conditions found following shingle removal. Having said that, the interior second floor ceiling shows few water stains. This indicates that the roof is not yet leaking badly. The property owner submitted a contractor's bid of \$35,770 to replace the roof. In City staff's opinion that is higher than the average cost to replace a similar roof but is still within range of a reasonable estimate and includes all new roof decking. City staff does not have reason to believe this bid to be inaccurate.

Roof needs replacement

7. We were unable to access the attic so we couldn't see the roof structure. However, based on what we could observe from the ground and the evidence of moisture on ceilings directly under the roof we can surmise that there is some damage to the roof structure. The shingles need to be replaced on the entire roof and most of the flashing would need to be replaced as well.

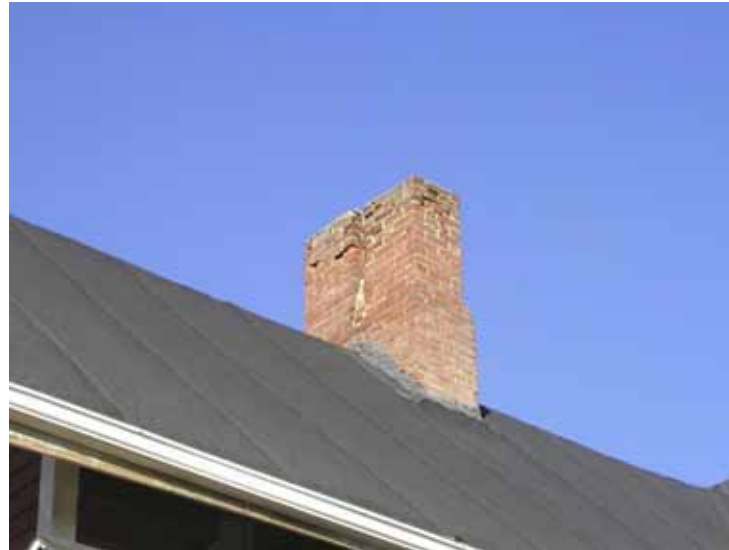
Roll roofing misapplied and minor brick damage to chimney

8. There are some bricks missing from the chimney above the roof that need to be replaced and some tuck pointing done.

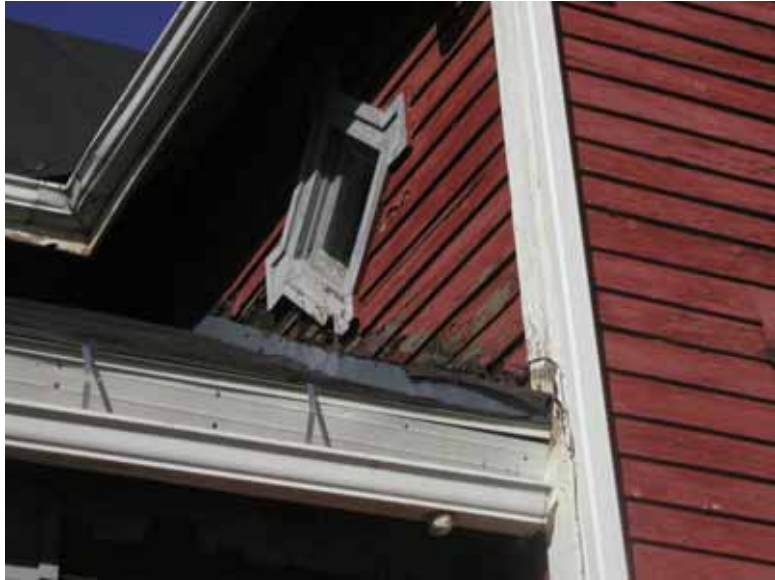
Incorrect roof flashing allows moisture damage

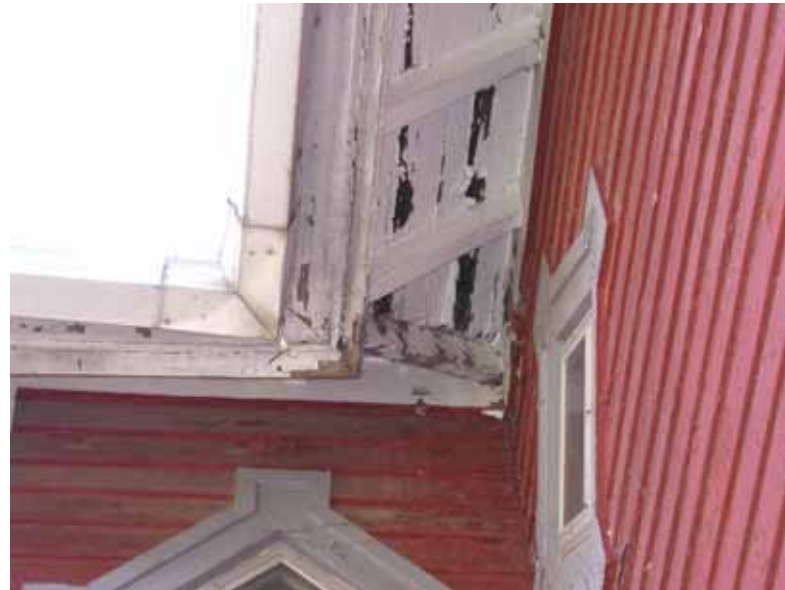
Exterior Paint Condition. The exterior paint is failing. In some places exterior paint is sheeting off the wood lap siding which may indicate an interior moisture source pushing off the paint. The property owner submitted a contractor's low bid of \$8,467 to spot prime and repaint the entire exterior with a quality paint (MAB). It should be noted that the entire building should be primed before painting rather than simply spot primed. A second painting bid of \$17,600 includes full priming and painting with quality paints (Duration) and therefore is used for this analysis. City staff does not have reason to believe these bids to be inaccurate. It should also be noted that this cost does not include repair or replacement of deteriorated woodwork and trim. Considerable rot shows around some windows. The building shows signs of having insulation blown into the balloon-frame wall cavities, and old house experts caution that doing so can lead to reoccurring paint failure.

Eaves with failing paint

5. The outside of the building is basically structurally sound but there is a lot of rot around windows and at areas of wood trim detailing.
6. Paint is peeling off the entire exterior of the building and the wood below is bare.

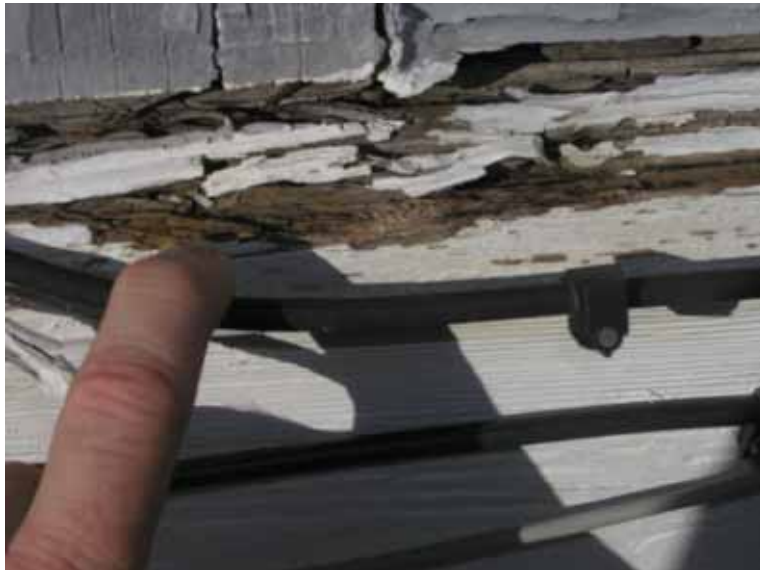
Example of moisture damage around windows

3. There are some areas of plaster that are "swollen" indicating an invasion of moisture. This was primarily around windows and under the roof.
4. Some of the interior trim around windows is badly decayed and there are some window sashes that show signs of rot.

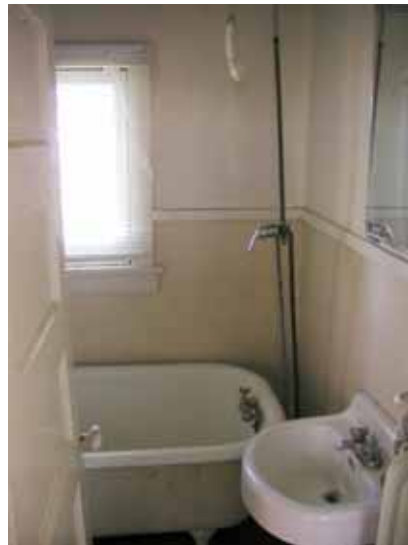
Plumbing. The plumbing for the three apartments meets the minimum property maintenance requirements, but the kitchen and bathroom fixtures are very outdated, and the bathroom units are quite small by modern standards.

Unit 2: bathroom

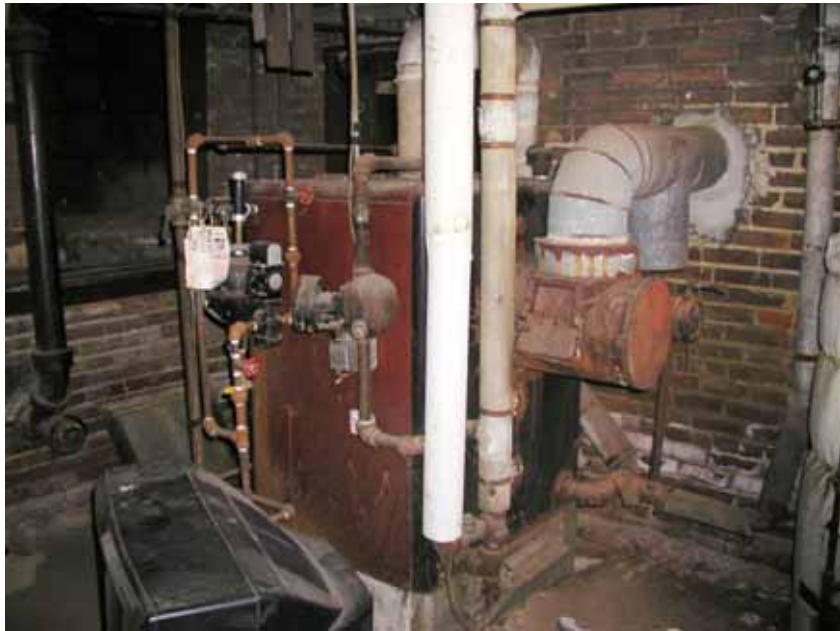
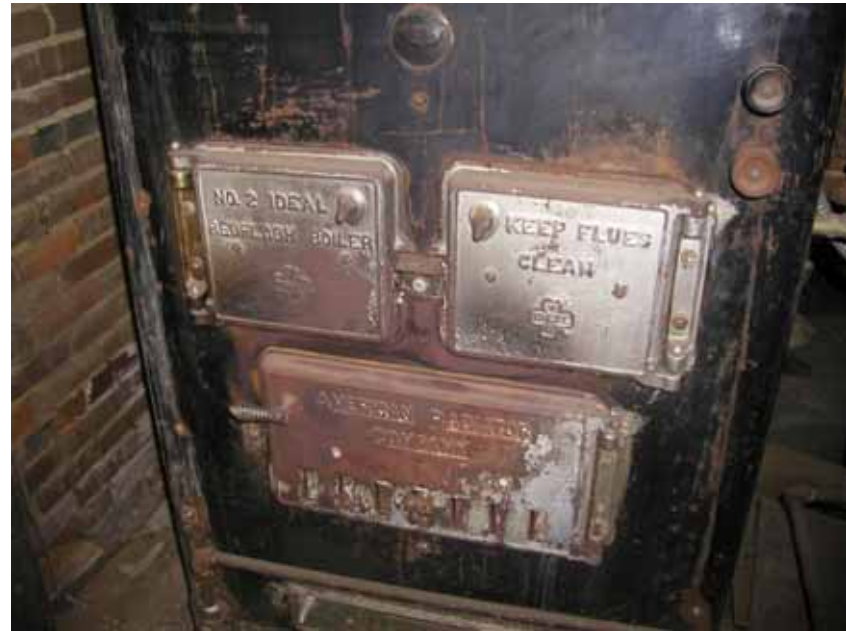
Heating and Cooling. The house is heated by hot water radiators fired by a boiler in the basement. The boiler is quite old and appears to be at or near the end of its useful life. Judging by its appearance, the boiler may be a coal-fired boiler converted to natural gas. If so the original boiler could be 50 or more years old. The house has no central or zoned air conditioning other than window units. The property owner submitted a contractor's bid of \$14,448 to replace the boiler. City staff does not have reason to believe this bid to be inaccurate.

Basement: boiler

The boiler is old, inefficient and at the end of its useful life. If not now, it will need to be replaced in the next few heating seasons. There are no provisions for air-conditioning available to any of the units.

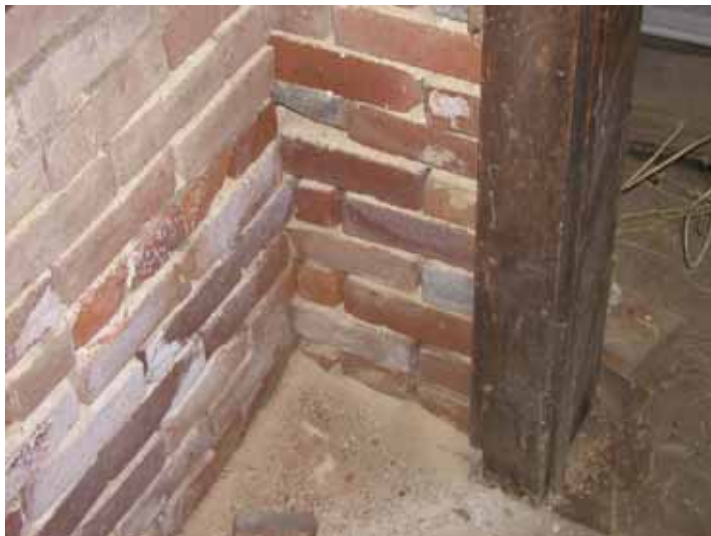
Structural condition. The building appears to be structurally sound. Neither the foundation nor plaster walls show significant cracks, settling, displacement, bowing, or spalling. Selective repointing of brick mortar joints in the foundation would insure structural integrity but is not urgent. Some minor areas of "swollen" plaster indicate water infiltration, but again the problem is not urgent.

Basement: mortar joints need repointing

1. The foundation of the building is in surprisingly good condition. I observed no major cracking or lateral displacement of the foundation walls and no indication of excessive settling. There is evidence of deterioration of some of the mortar and bricks that would need to be repaired by a mason but this problem is not urgent. There is some minor evidence of termite damage to the floor structure as well as some small areas of floor sheathing rot around plumbing fixtures.

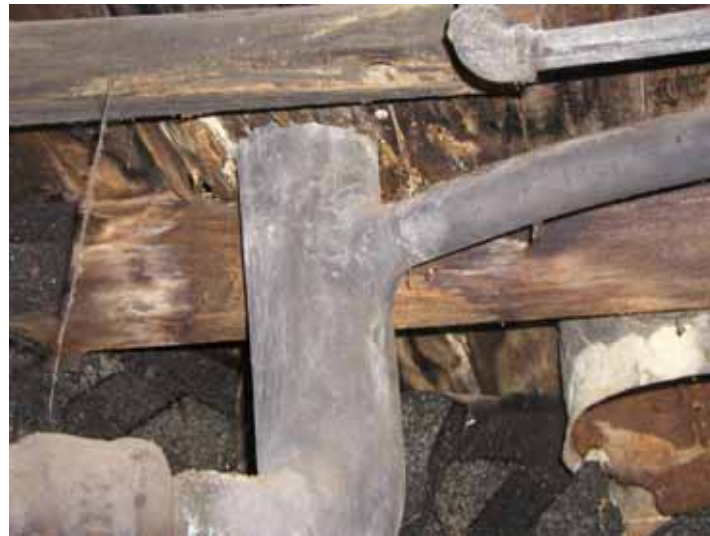
existing plumbing showing long-term moisture damage
