SUBJECT: 1404 S. Lincoln Avenue (Zeta Tau Alpha Sorority House). Case No. HP 2013-L-01

The Repair and Thermal Upgrading of Historic Steel Windows

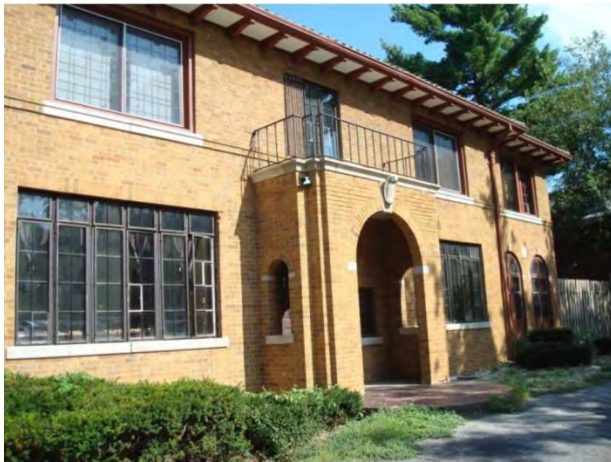
1004 S. Lincoln Ave. -- Before

Alpha Rho Chi House Rehabilitation

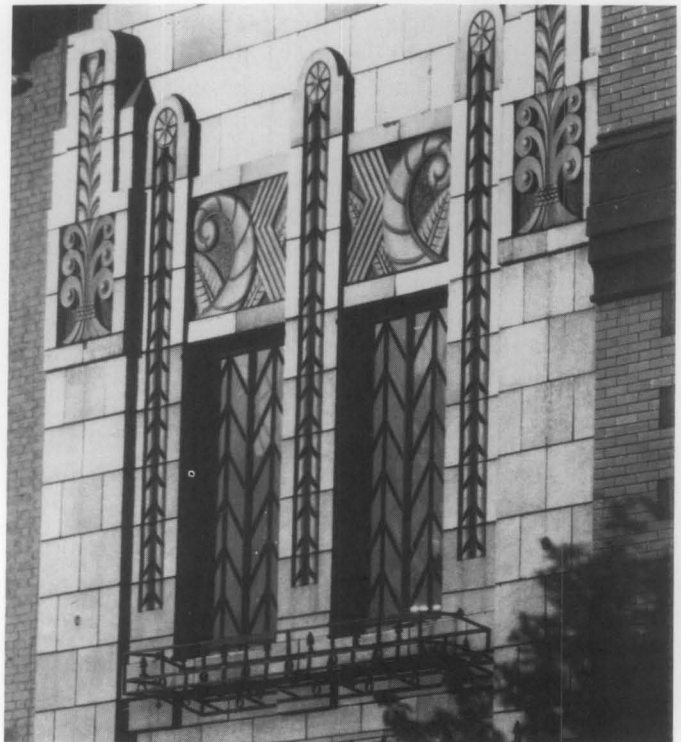
Fig. 1 Often highly distinctive in design and craftsmanship, rolled steel windows play an important role in defining the architectural character of many later nineteenth and early twentieth century buildings. Art Deco, Art Moderne, the International Style, and Post World War II Modernism depended on the slim profiles and streamlined appearance of metal windows for much of their impact. Photo: William G. Johnson.

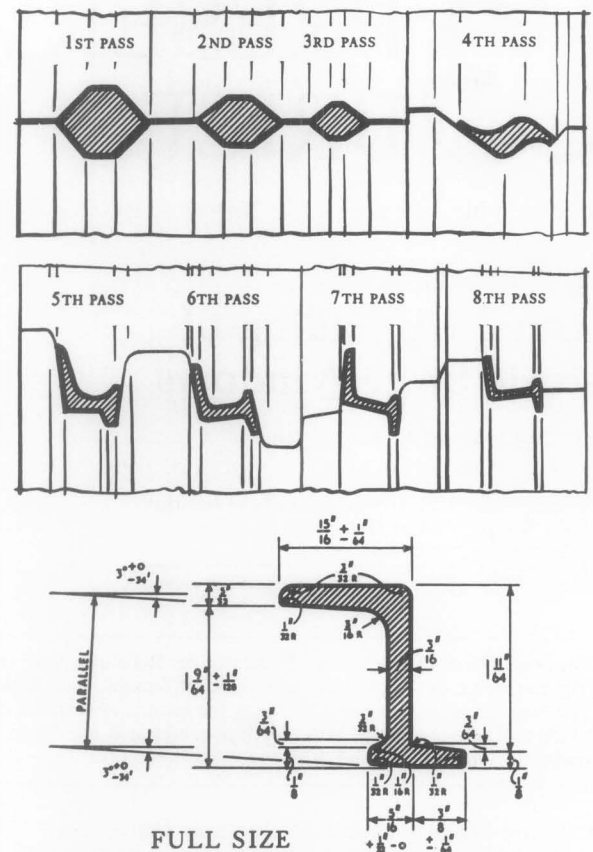
ROLLING SECTION FROM BAR

Fig. 2. The process of rolling a steel bar into an angled section is illustrated above. The shape and size of the rolled section will vary slightly depending on the overall strength needed for the window opening and the location of the section in the assembly: subframe, frame, or sash. The $\frac{1}{8}$ " thickness of the metal section is generally standard. Drawing: *A Metal Window Dictionary*. Used with permission.

As in the process of making rails for railroads, rolled steel windows were made by passing hot bars of steel through progressively smaller, shaped rollers until the appropriate angled configuration was achieved (see fig. 2). The rolled steel sections, generally $\frac{1}{8}$ " thick and 1" - 1 $\frac{1}{2}$ " wide, were used for all the components of the windows: sash, frame, and subframe (see fig. 3). With the addition of wire glass, a fire-resistant window resulted. These rolled steel windows are almost exclusively found in masonry or concrete buildings.

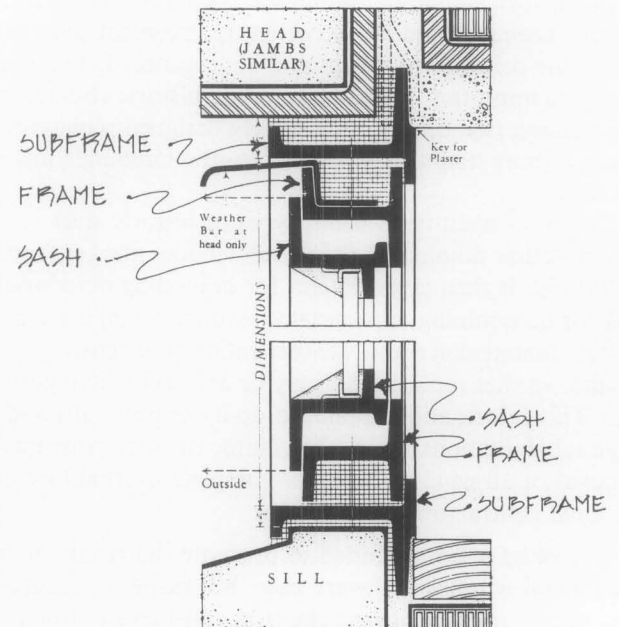
Fig. 3 A typical section through the top and bottom of a metal window shows the three component parts of the window assembly: subframe, frame, and sash. Drawings: Catalogue No. 15, January 1931; International Casement Co, Inc., presently Hope's Architectural Products, Inc., Jamestown, NY. Used with permission.

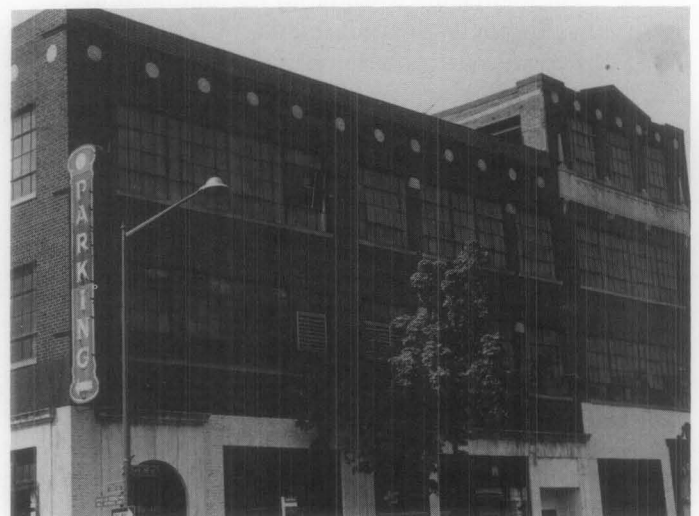
Fig. 5 Windows often provide a strong visual element to relatively simple or unadorned industrial or commercial buildings. This design element should be taken into consideration when evaluating the significance of the windows. Photo: Michael Auer.

Other elements in assessing the relative importance of the historic windows include the design of the windows and their relationship to the scale, proportion, detailing and architectural style of the building. While it may be easy to determine the aesthetic value of highly ornamented windows, or to recognize the importance of streamlined windows as an element of a style, less elaborate windows can also provide strong visual interest by their small panes or projecting planes when open, particularly in simple, unadorned industrial buildings (see fig. 5).

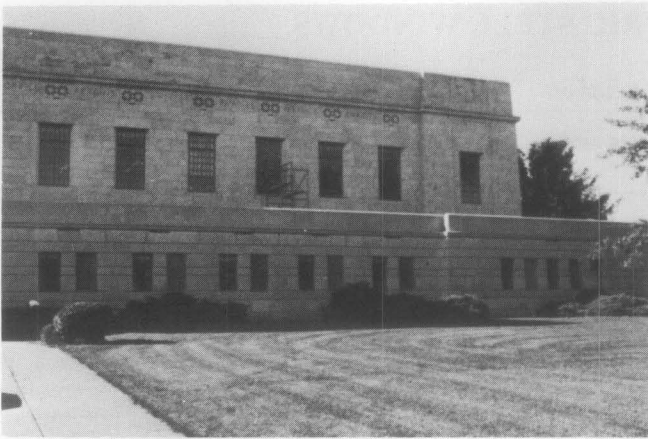
Fig. 6 a. View of the flanking wing of the State Capitol where the rolled steel casement windows are being removed for repair.

Fig. 6. The repair and thermal upgrading of the historic steel windows at the State Capitol, Lincoln, Nebraska. This early twentieth century building, designed by Bertram Goodhue, is a National Historic Landmark. Photos: All photos in this series were provided by the State Building Division.

Damage to windows may be so severe that the window sash and sometimes the frame must be removed for cleaning and extensive rust removal, straightening of bent sections, welding or splicing in of new sections, and reglazing. These major and expensive repairs are reserved for highly significant windows that cannot be replaced; the procedures involved should be carried out only by skilled workmen. (see fig. 6a—6f.)

Following are illustrations of the repair and thermal upgrading of the rolled steel windows in a National Historic Landmark (fig. 6). Many of the techniques described above were used during this extensive rehabilitation. The complete range of repair techniques is then summarized in the chart titled *Steps for Cleaning and Repairing Historic Steel Windows* (see fig. 7).

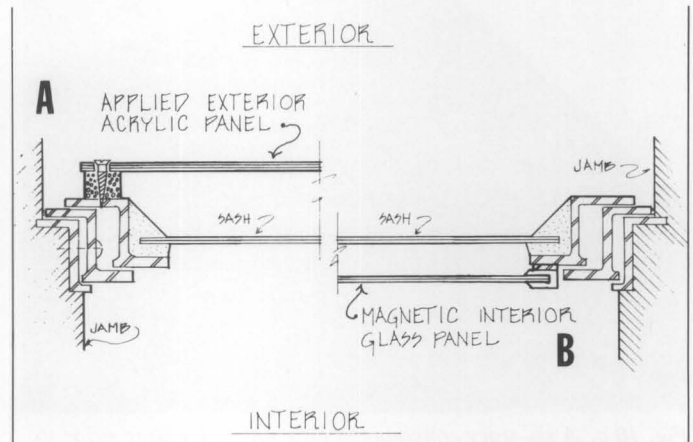
Fig. 9 Two examples of adding a second layer of glazing in order to improve the thermal performance of historic steel windows. Scheme A (showing jamb detail) is of a 1/4" acrylic panel with a closed cell foam gasket attached with self-tapping stainless steel screws directly to the exterior of the outwardly opening sash. Scheme B (showing jamb detail) is of a glass panel in a magnetized frame affixed directly to the interior of the historic steel sash. The choice of using glass or acrylic mounted on the inside or outside will depend on the ability of the window to tolerate additional weight, the location and size of the window, the cost, and the long-term maintenance outlook. Drawing: Sharon C. Park, AIA.

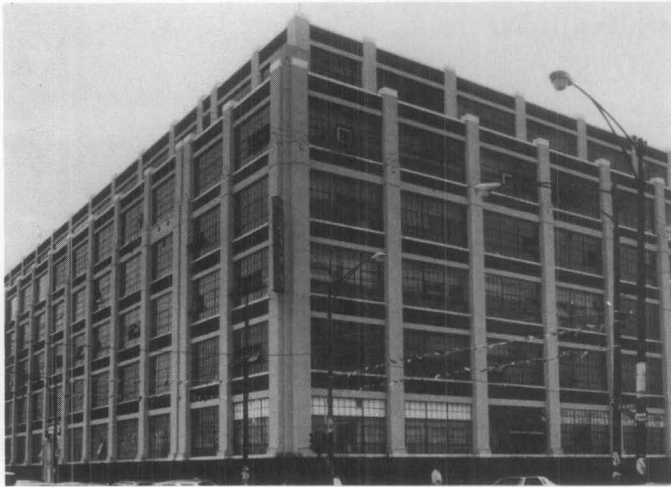
Fig. 10 a. A six-story concrete manufacturing building prior to the replacement of the steel pivot windows. Photo: Charles Parrott.

historic windows, most of these manufacturers can reproduce the historic configuration if requested, and the cost is not excessive for large orders (see figs. 10a and 10b). Some manufacturers still carry the standard pre-World War II multi-light windows using the traditional 12" x 18" or 14" x 20" glass sizes in industrial, commercial, security, and residential configurations. In addition, many of the modern steel windows have integral weatherstripping, thermal break construction, durable vinyl coatings, insulating glass, and other desirable features.

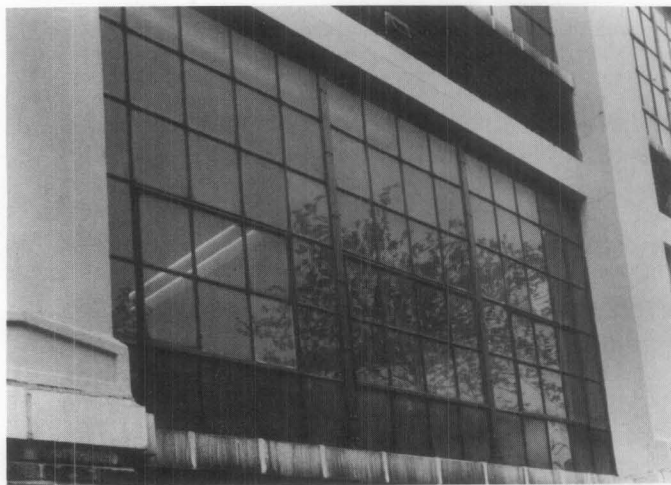
Fig. 10 b. Close-up view of the new replacement steel windows which matched the multi-lighted originals exactly. Photo: Charles Parrott.
